**Subject: Submittal of Final Remedial Action Report  
Ottawa Radiation Areas, Operable Unit 4 (OU4), NPL-8 Frontage Property  
Ottawa, LaSalle County, Illinois  
Remedial Action Contract (RAC) 2  
Contract No. EP-S5-06-02, Work Assignment No. 334-RARA-059Z**

**REMEDIAL ACTION REPORT**

**OTTAWA RADIATION AREAS  
NPL-8 FRONTAGE PROPERTY SITE  
OPERABLE UNIT 4  
LASALLE COUNTY, ILLINOIS**

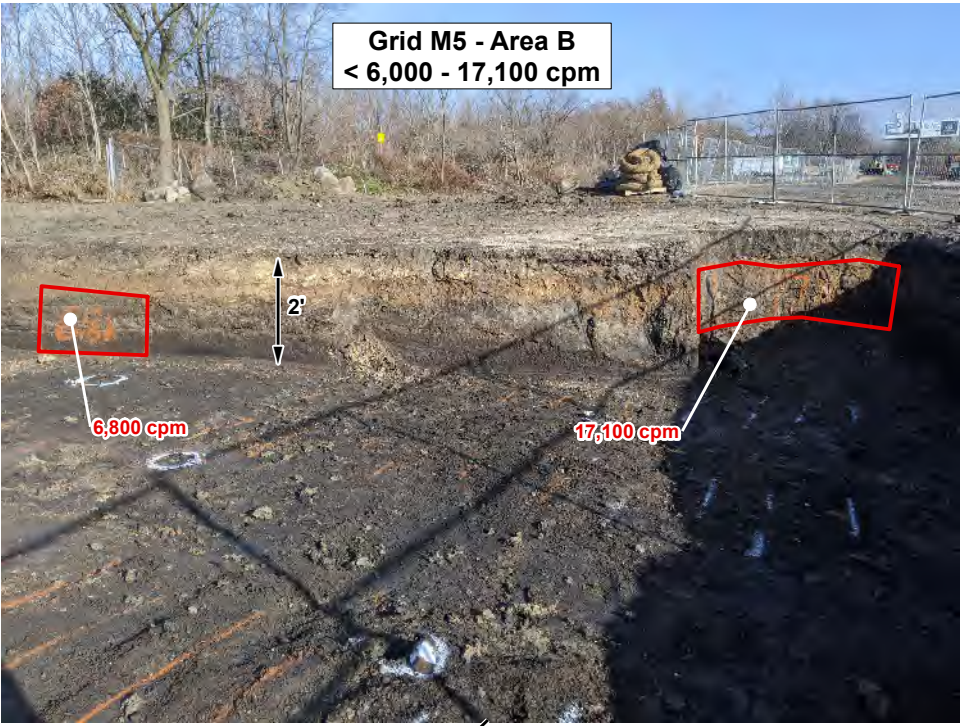
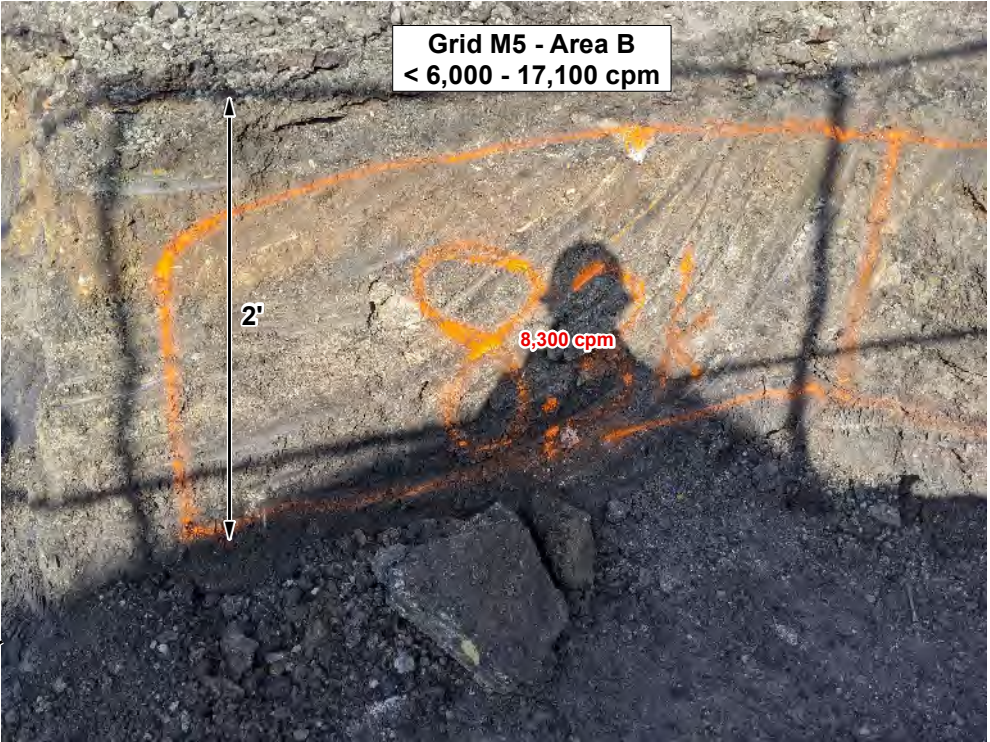
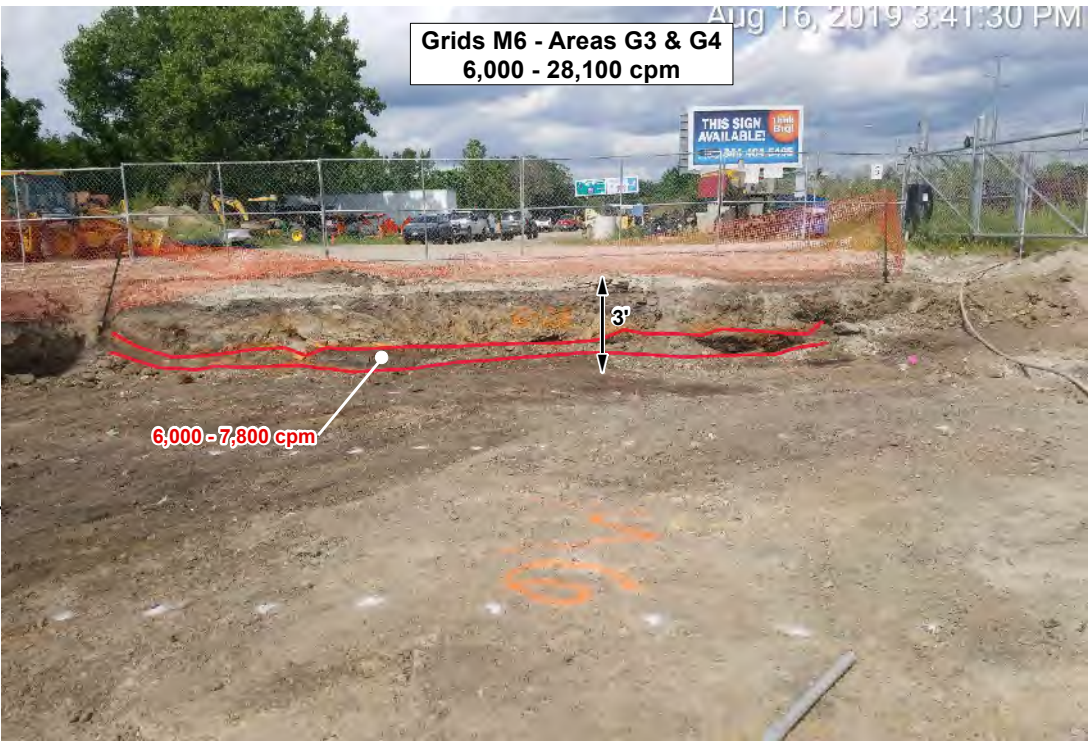
FIGURE 11  
POST-EXCAVATION  
VERIFICATION SAMPLE RESULTS

All homogenized verification samples were split into two separate aliquots; 100 milliliters (mL) of the verification sample was submitted to the on-site field laboratory for preliminary gamma spectroscopy analysis of total radium. The remaining 500 mL collected was submitted to GEL Laboratories for analysis of radium-226 and radium-228 to confirm that any radium-226 exceeding the RAO had been removed. A total of 83 verification samples were collected from the site, including nine duplicate samples. Figure 10 shows the locations of all verification samples. All off-site analytical results for the verification samples were below the RAO (6.2 pCi/g). Table 3 and Figure 11 present verification soil sample results.

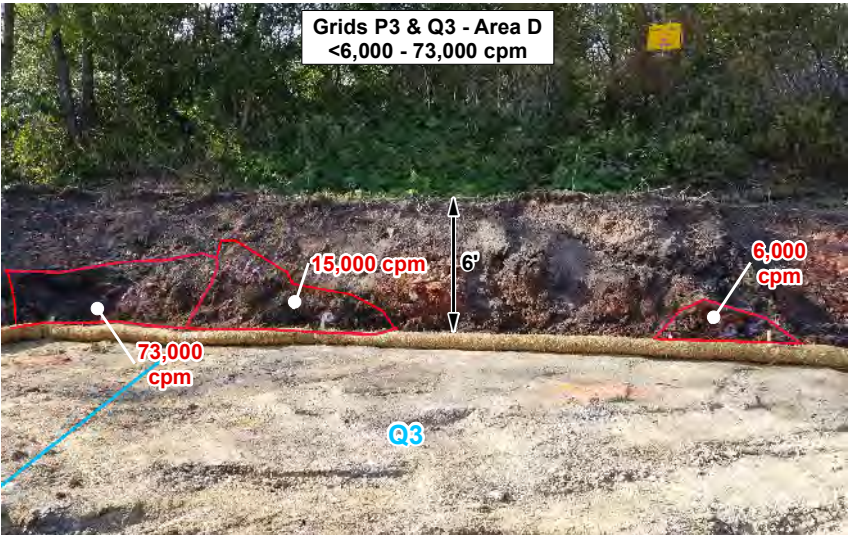
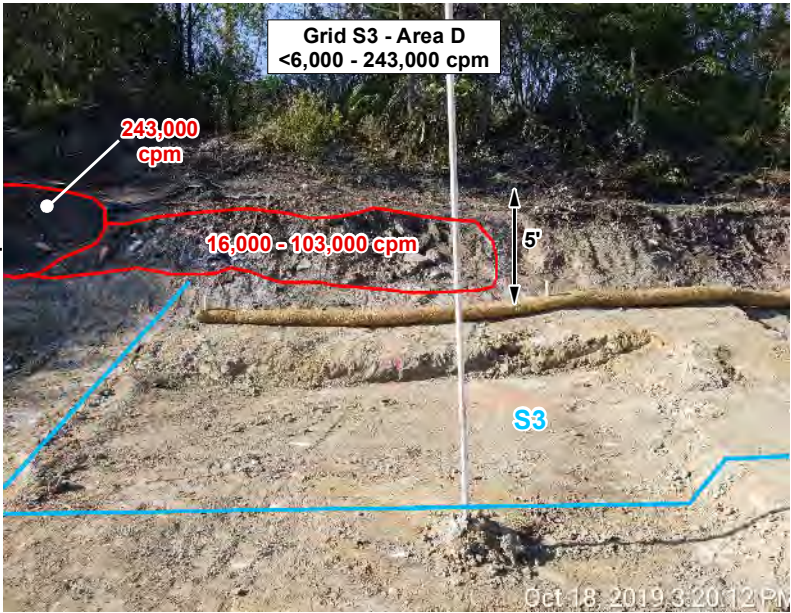
FIGURE 12B  
POST-EXCAVATION SIDEWALL SURVEYS OF  
AREAS A & B - ADJACENT TO THE LANDFILL

Within excavation Areas A, B, D, G3, G4, HS-3, and the Bill Walsh property excavation, elevated gamma survey readings (above 6,500 cpm) remained in the excavation walls along the NPL-8 Landfill or Area C boundaries, and on the Bill Walsh property. However, the excavation floors were verified as clean except as discussed in Section 3.2.2. Further excavation into the NPL-8 Landfill, Area C, or the Bill Walsh property were not a part of the original scope of work for this RA; therefore, no additional excavation was conducted. However, prior to backfilling these areas, additional investigation was conducted to investigate the excavation walls. Specifically, a detailed wall survey was first conducted using a 2x2 NaI detector (Ludlum Model 44-10) coupled with a scaler/rate meter (Ludlum Model 2221). SulTRAC then collected discrete and composite wall samples as needed to supplement the wall survey data. Where radium-226 contamination was identified to remain in place along an excavation wall, orange geofabric was placed as a visual demarcation barrier for potential future RA activities. Figures 12A through 12F present gamma survey and soil sampling results.

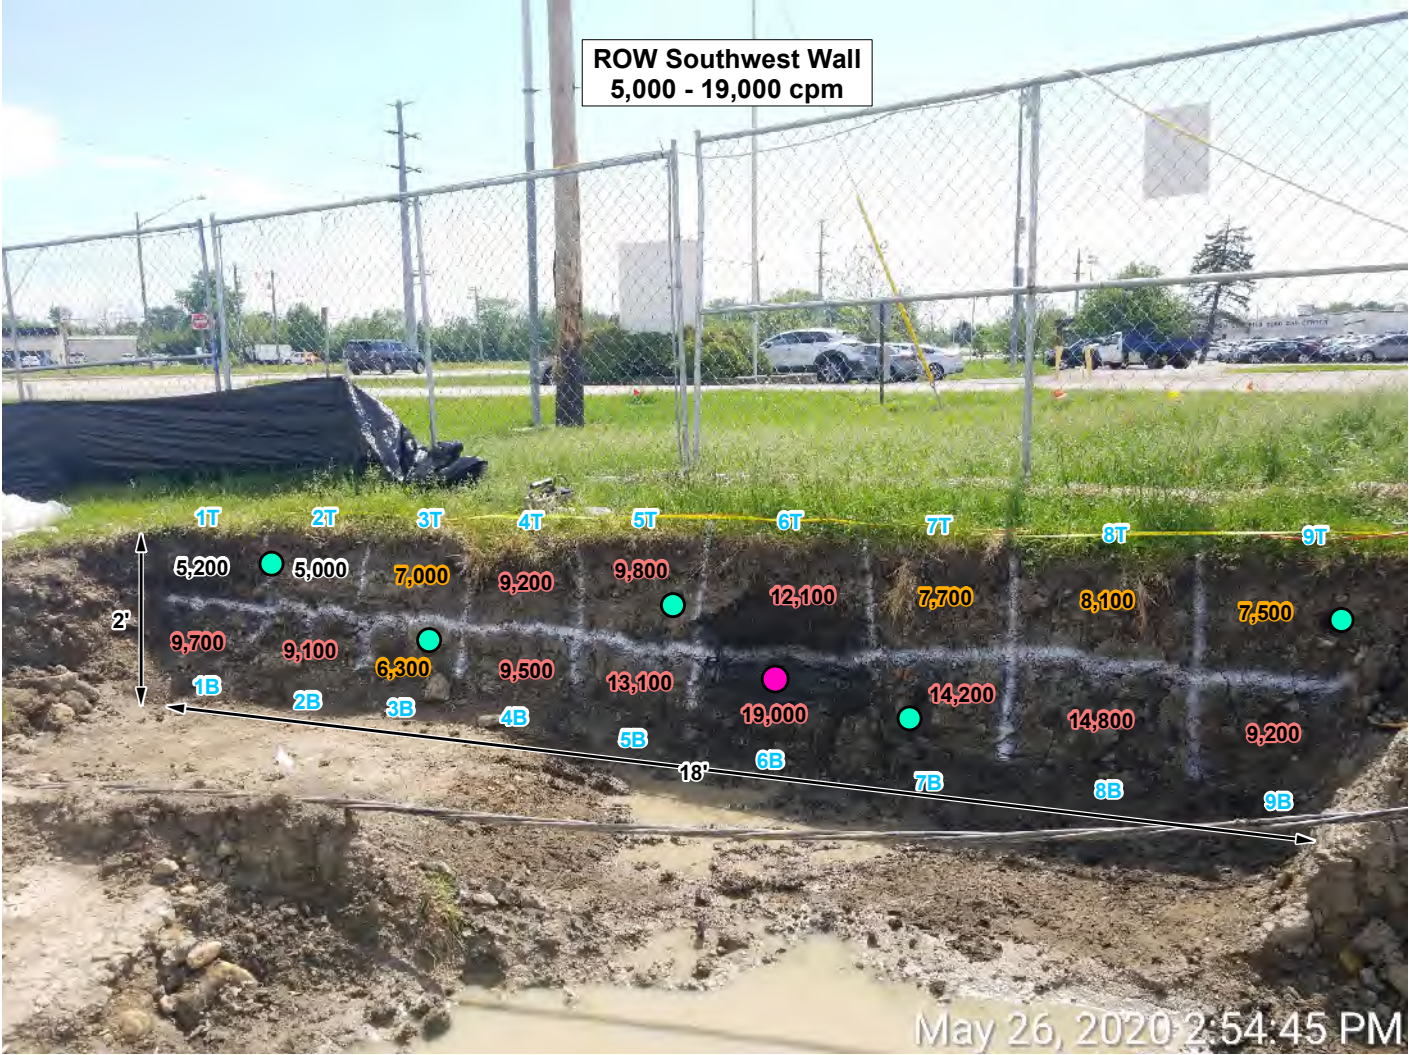
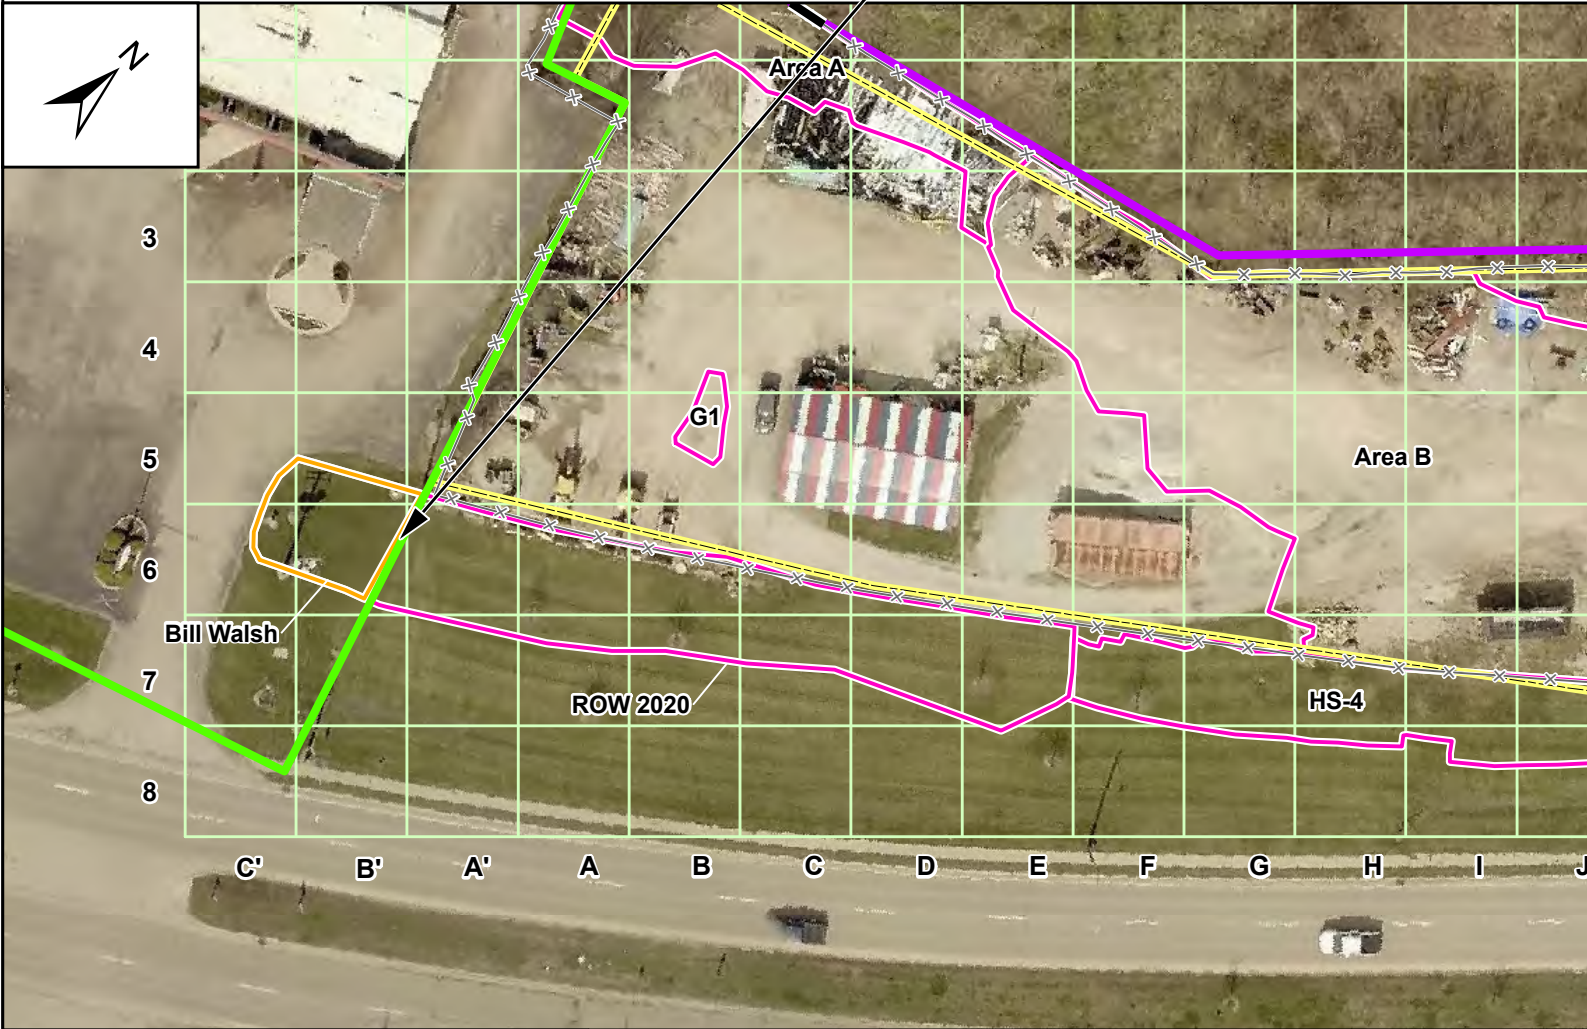
**FIGURE 12F**  
**POST-EXCAVATION SIDEWALL SURVEY OF**  
**ROW SOUTHWEST WALL**

View of the southwestern-most ROW excavation wall. The wall was split in half vertically (top "T" and bottom "B") and then split into 9 columns each 2 feet wide. Each box of the grid was then screened by SAHCl and the highest gamma activity was recorded. All readings are presented in counts per minute (cpm).

- 5-point composite sample locations, On-site gamma spectroscopy result 5.74 pCi/g
  - Discrete sample location taken from the 19,000 cpm hotspot, Onsite gamma spectroscopy result 95.03 pCi/g

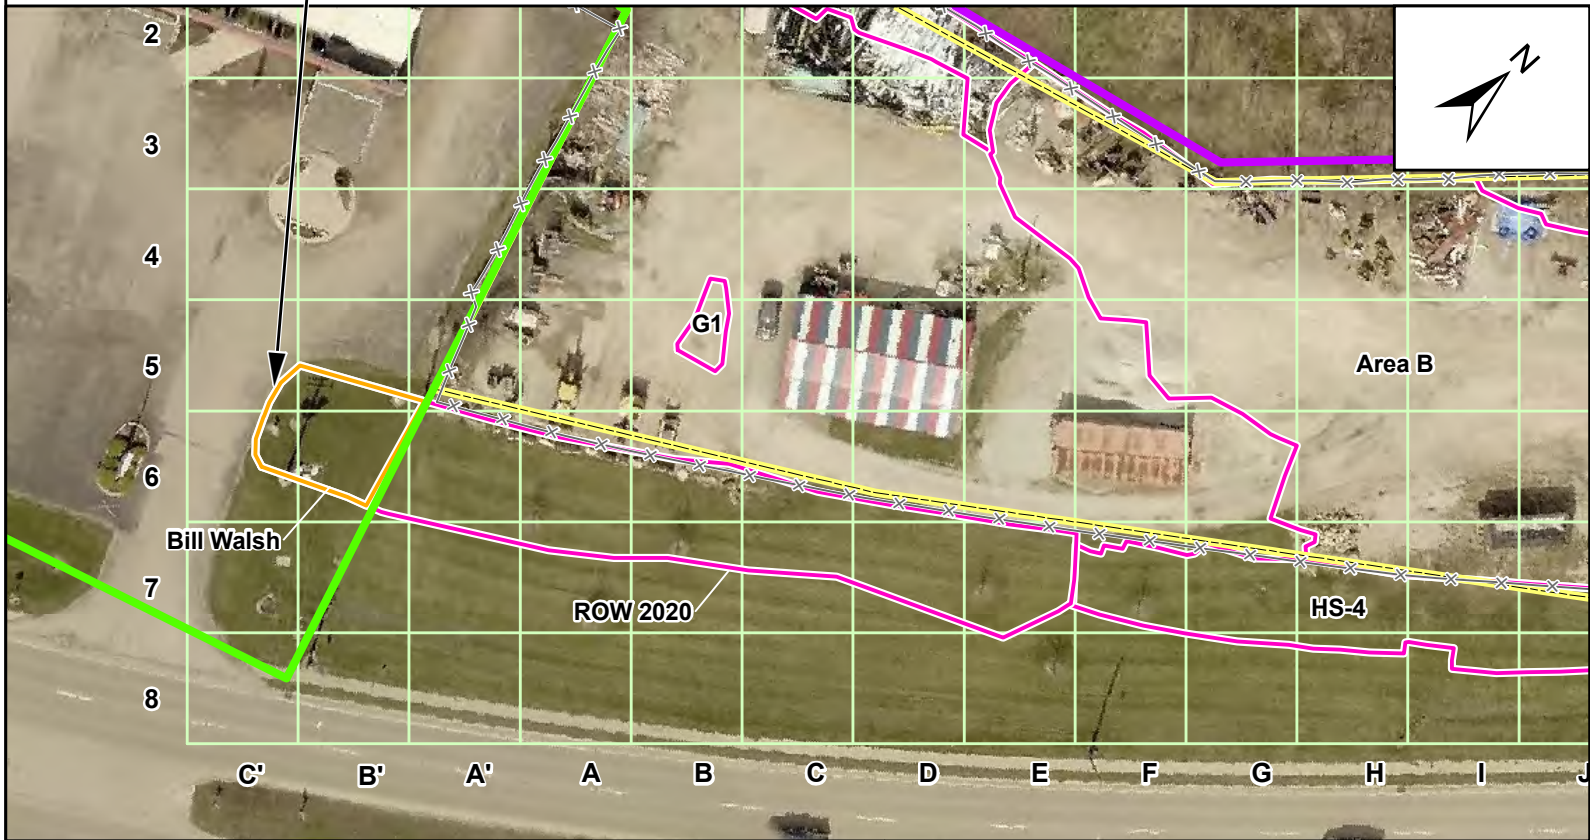
**FIGURE 12G**  
**POST-EXCAVATION SIDEWALL SURVEY OF**  
**BILL WALSH PROPERTY EXCAVATION**  
**SOUTHWEST WALL**

View of the southwestern-most excavation wall adjacent to the Bill Walsh asphalt driveway entrance. The wall was split vertically into 3 rows with each row 2 feet (top "T," middle "M," and bottom "B"), and then split into 12 columns each 2 feet wide. Each box of the grid was then screened by SAHCl and the highest gamma activity was recorded. All readings are presented in counts per minute (cpm).

- Suspected historical storm-water drainage culvert, Gamma activity within the culvert was 12,000 cpm
  - 5-point composite sample locations, Onsite gamma spectroscopy result 7.60 pCi/g
  - Discrete sample location taken from the 24,400 cpm hotspot, Onsite gamma spectroscopy result 116 pCi/g
  - Bill Walsh Property Excavation Area
  - Final Excavation Area
  - Frontage Property Boundary
  - Approximate Landfill Boundary
  - Approximate Bill Walsh Property Boundary
- cpm = counts per minute  
pCi/g - Picocuries Per Gram

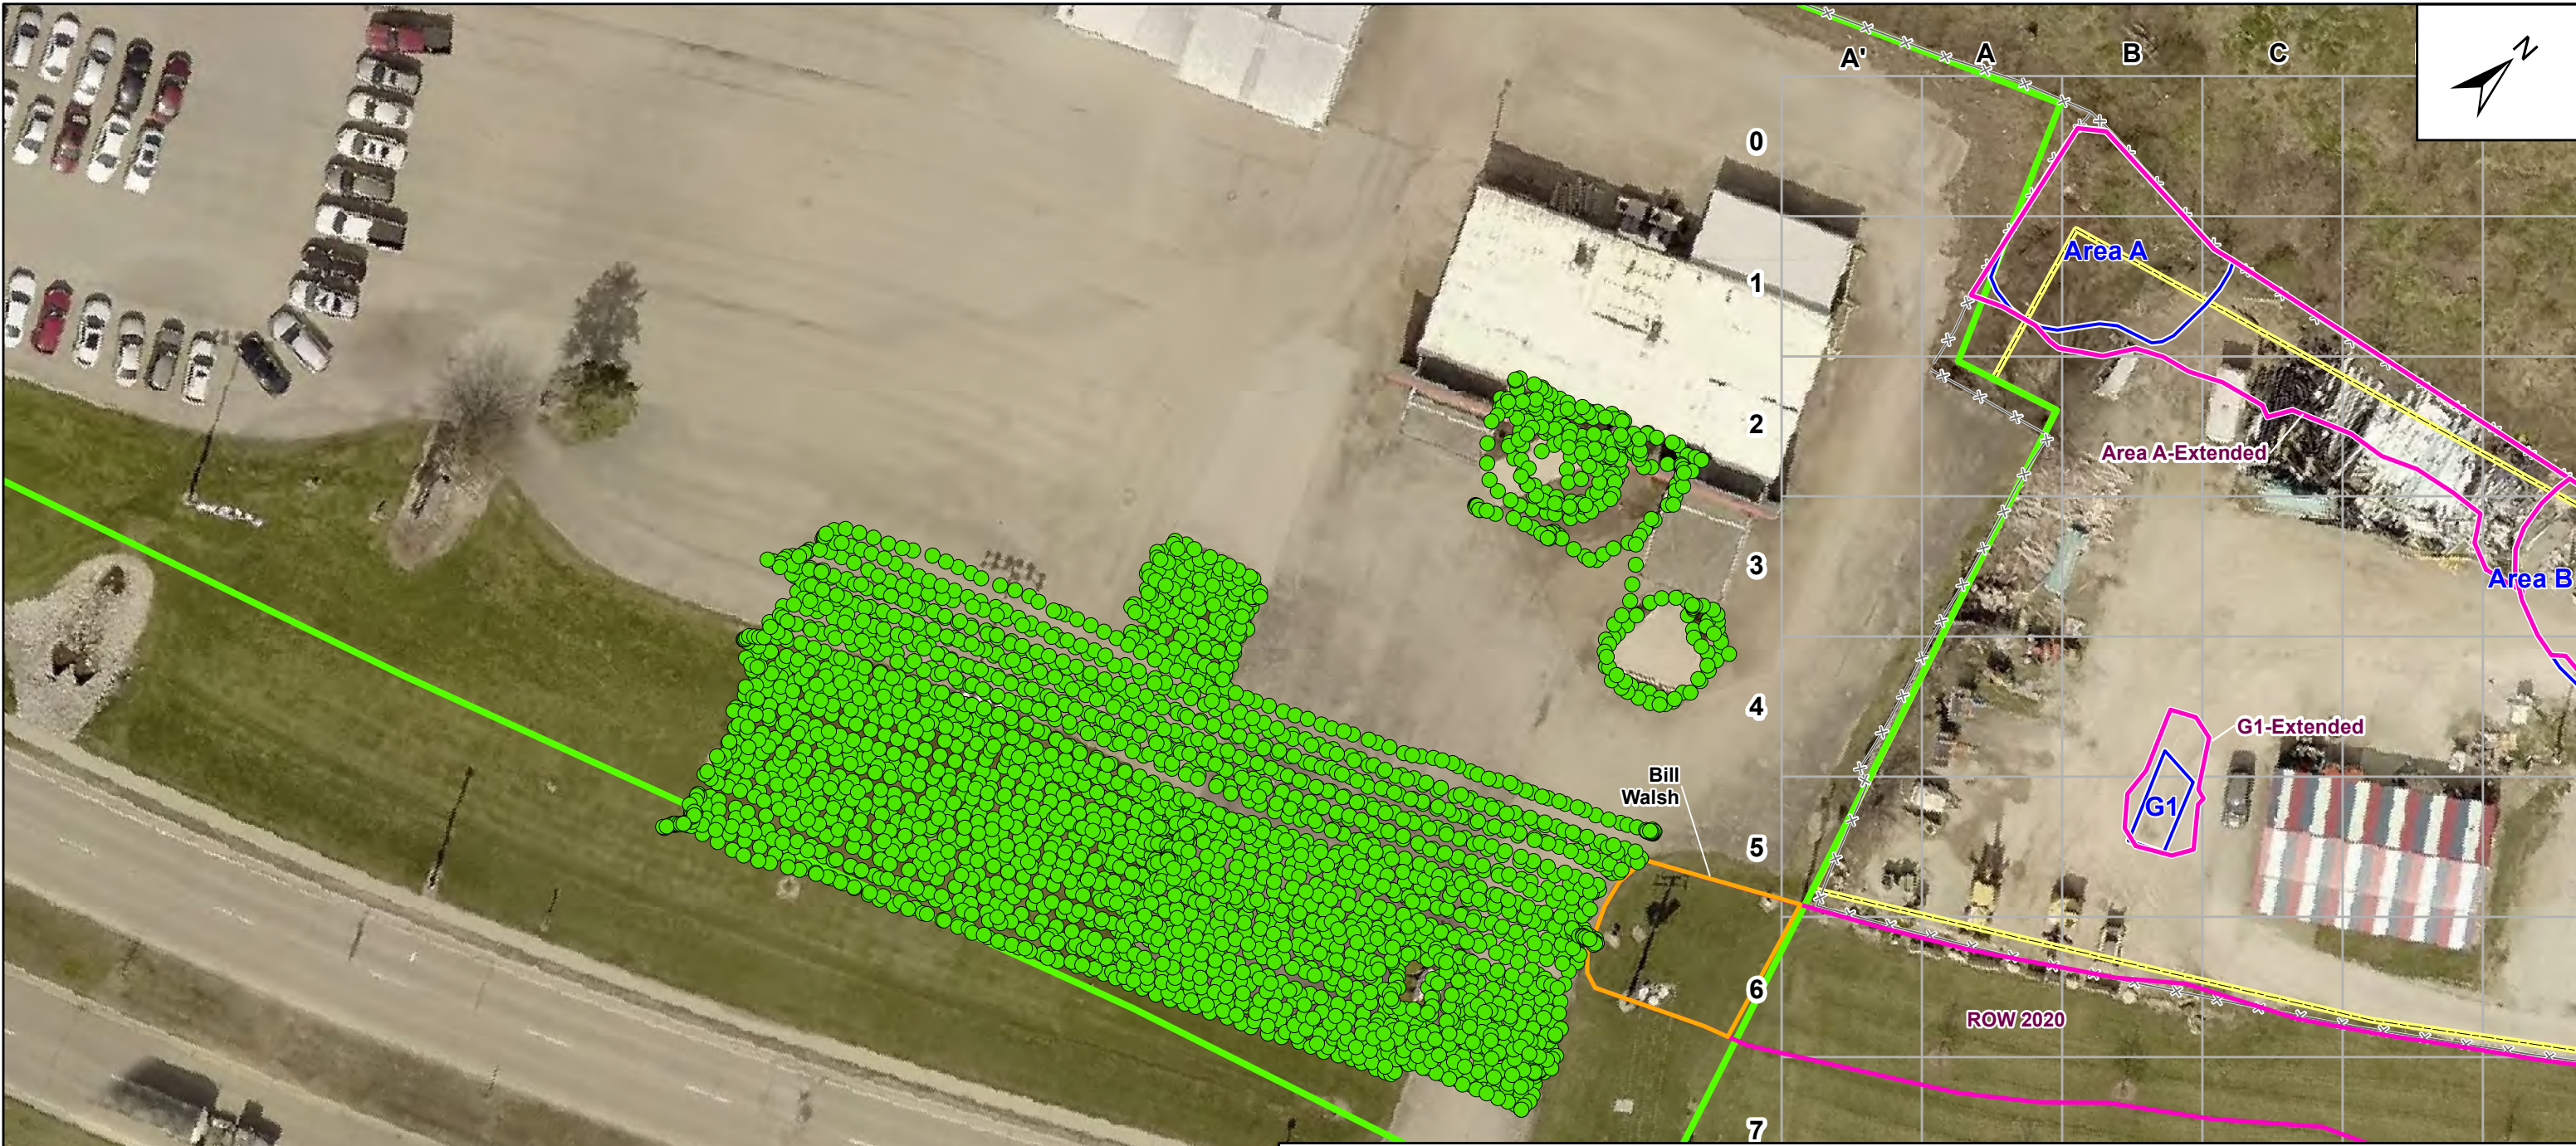
**FIGURE 15**  
**ESTIMATED EXTENT OF REMAINING ROW**  
**CONTAMINATION WITH INVESTIGATIVE**  
**TEST PIT LOCATIONS AND RESULTS -**  
**GAMMA SURVEY AND FIELD GAMMA SPECTROSCOPY**

southwest of Area HS-4 in the ROW. All excavated material was placed back in the same excavation at the depths from which it was removed. Radium-226 contamination ranging from 6.64 to 15.46 pCi/g from the surface to 4 feet bgs was detected in test pits 1 (TP-01), TP-03, TP-04, and TP-06. Radium-226 contamination of 13.35 pCi/g from the surface to 2 feet bgs was detected in Test Pit 8. Figure 15 presents test pit gamma survey and on-site gamma spectroscopy results.

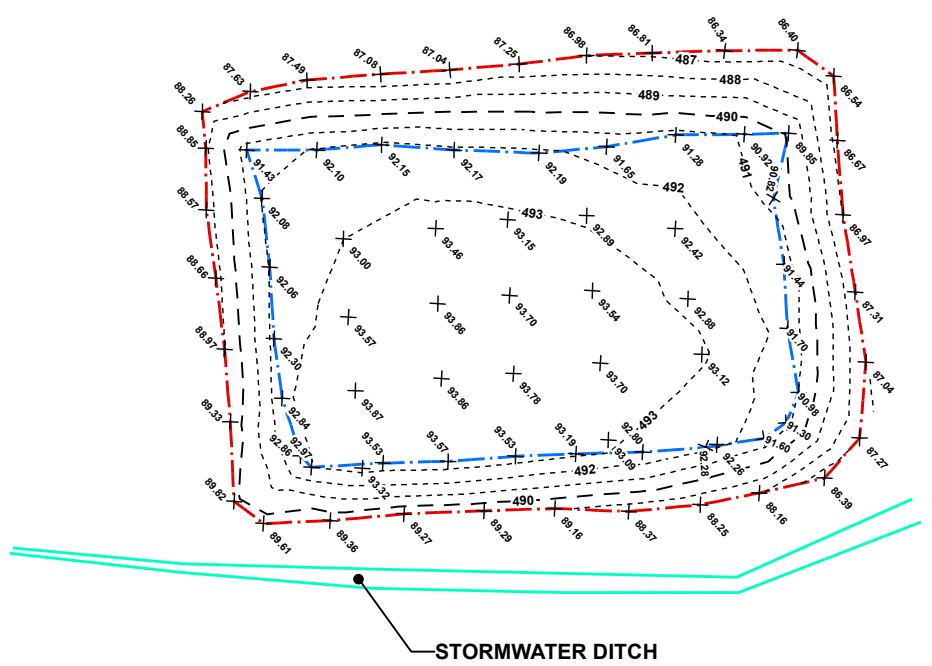
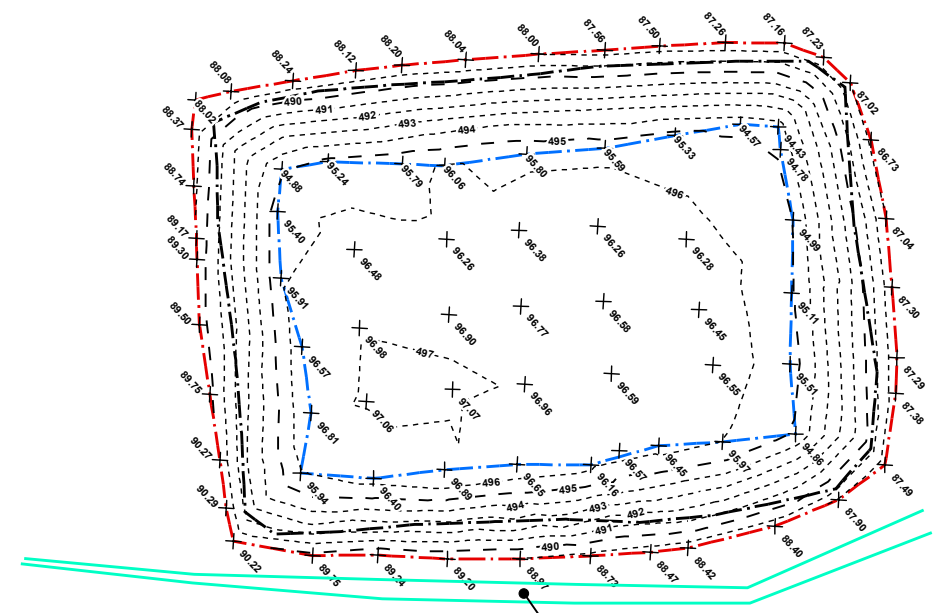
**FIGURE 19  
COMPACTED CONTAMINATED SOIL  
STOCKPILE GRADES**

Stockpile Final Grading Survey drawing is provided by Renwick & Associates, Inc.  
20200818 saved ACAD ver 2013 (#18.206.1) for TriEco, LLC - NPL-8 Site -Stockpile Final Grading Survey.dwg

Stockpile Contaminated Soil Survey drawing is provided by Renwick & Associates, Inc.  
20200817 saved ACAD ver 2013 (#18.206.1) for TriEco, LLC - NPL-8 Site -Stockpile Contaminated Soil Survey.dwg
